Water tightness test of SafetyBag in  
accordance with ETAG 022, Annex F

CLIENT(S) Probata AS CLIENT'S REF. Geir Skjelseth

PROJECT NO. 3B040940 NUMBER OF PAGES/APPENDICES: 6 / 0

REPORT NO. SBF20120214 ISBN -

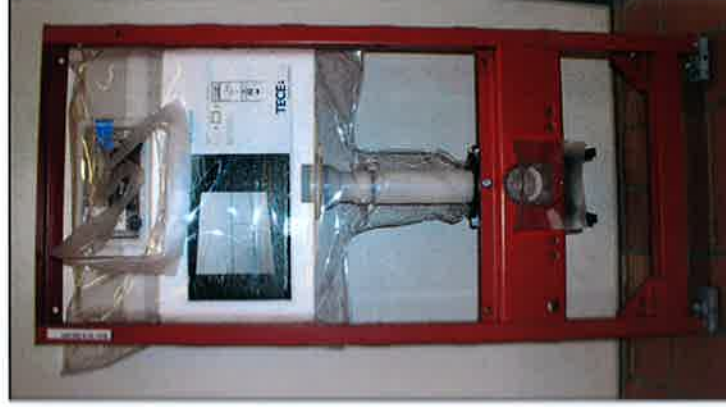
Fig. 3.1 – TECEprofil with SafetyBag

The test object belongs to an installation module for wall-hung WC pans. The plastic bag is covering the cistern; see Figure 3.1 and Table 3.1. The intention of the plastic bag is to prevent possible water leakages from the hidden cistern to reach the inside wall construction. The water leakage will instead be detected through the front cover or the water supply connection to the wall hung WC pan from the cistern.

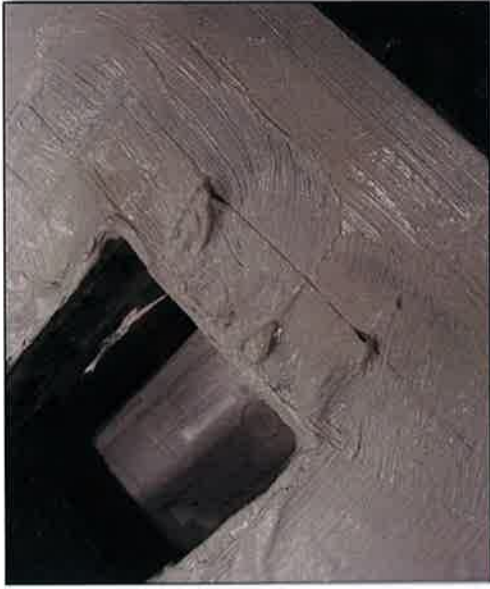
Fig. 3.2: Test specimen – front cover

Figure 3.2 and 3.3 shows pictures from the preparation of the test specimens. Figure 3.2 shows adding of liquid membrane around the front cover hole. The flange of the plastic bag was crumpled. SINTEF Building and Infrastructure was not able to stretch the flange of the plastic bag sufficiently during the assembling. These crumples may cause a problem when mounting of tiles. Figure 3.3 shows adding of liquid membrane around the water inlet to the WC pan. The flange of the plastic bag was nice and even around the water inlet hole.

No detection of moisture penetration was registered. No changes in appearance of the SafetyBag were registered. There might be problems as described in Chapter 3.2 regarding mounting of tiles around the front cover.

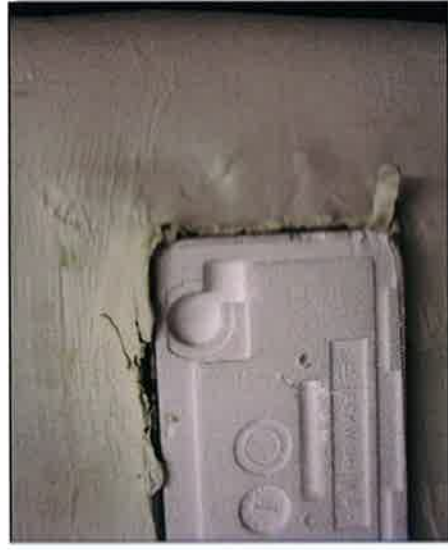
Fig. 4.1: Test specimen – front cover

Fig. 4.1 and 4.2 shows the test specimens after the test cycles were finished.
